Appendix L

Interim Report on WTC 7	L–1
L.1 Building Description	L–1
L.1.1 Purpose	L–1
L.1.2 Scope of Work	L–1
L.1.3 Introduction	L–1
L.1.4 Foundations	L–3
L.1.5 Con Edison Substation	L–4
L.1.6 Floor Systems	L–5
L.1.7 Columns	L–13
L.1.8 Column Transfer Trusses and Girders	L–14
L.1.9 Lateral System	L–15
L.2 Observations of Structural Collapse	L–17
L.2.1 Damage from WTC 1 and WTC 2 Collapses	L–17
L.2.2 Observed Fire Locations	L–22
L.2.3 WTC 7 Collapse Observations	L–26
L.2.4 Interpretation of Collapse Initiation Observations in Elevation	L–29
L.2.5 Interpretation of Collapse Progression Observations	L–30
L.2.6 Debris Field	L–33
L.2.7 Summary	L–33
L.3 Collapse Hypothesis	L–34
L.3.1 Introduction	L–34
L.3.2 Collapse Initiation Scenarios	L–36
L.3.3 Vertical Progression Scenarios	L–41
L.3.4 Horizontal Progression Scenarios	L–46
L.3.5 Summary of Working Collapse Hypothesis	L–50
L.3.6 Technical Approach for Analysis of the Working Collapse Hypothesis	L–52

Project 6 addresses the first primary objective of the technical investigation led by the National Institute of Standards and Technology (NIST) of the 47-story World Trade Center (WTC) disaster: to determine why and how WTC 7 collapsed. S

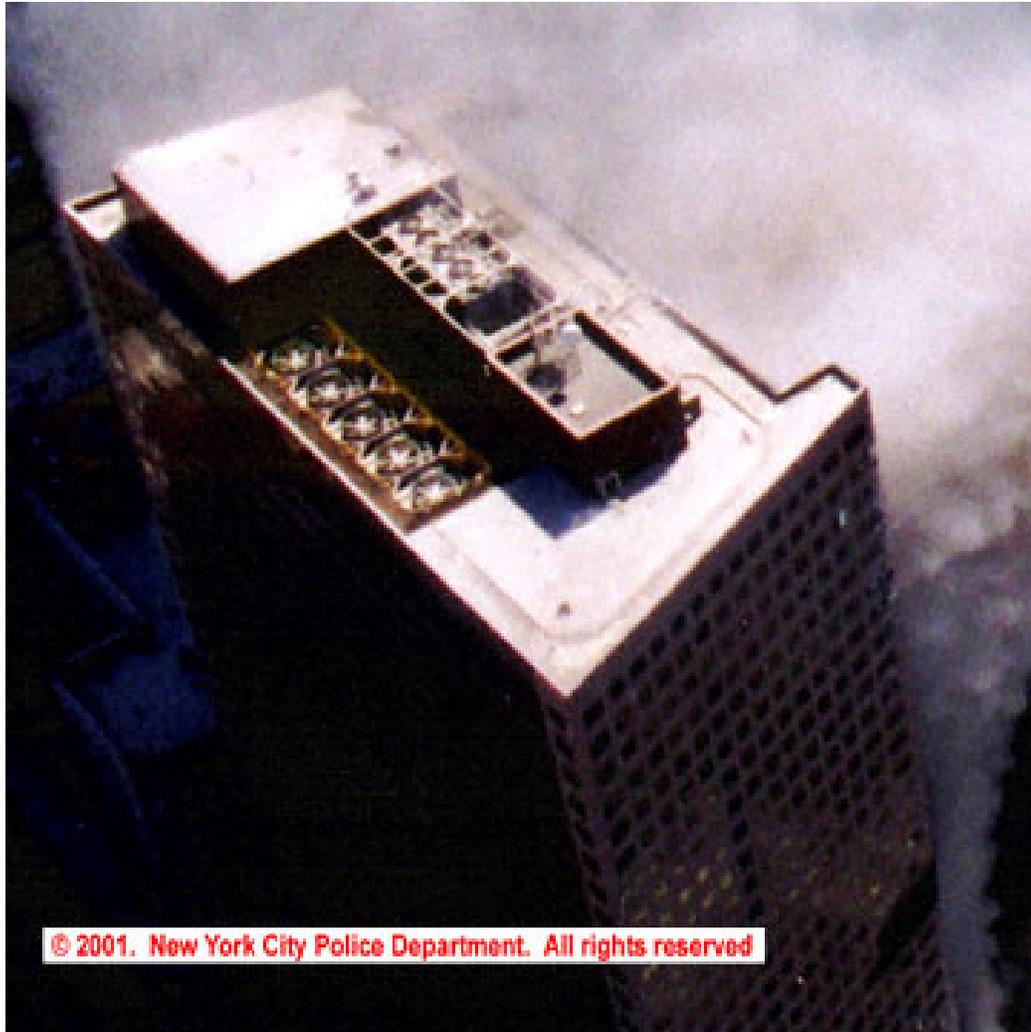
Photographs support some of these reports and show additional damage at the upper portions of the building. Figure L-21 is an aerial view of WTC 7 after the collapse of WTC 1. There is no visible debris on the roof; some minor damage is seen on the south side at the parapet wall. Figures L-22a and L-22b show the reported damage between Floors 8 to 18 at the southwest corner. Much of the damage above Floor 18 appears to be nonstructural. The black areas on the facade indicate areas of burned out fires. Note the heavy smoke obstructing any observations along the south face. Study of this photograph indicates that at least two exterior columns were severed. Figures L-23a and L-23b show the debris on Vesey Street in front of WTC 7 after the collapse of WTC 1. The pedestrian bridge (L-23a) and the

Figure L-21. Photograph of roof after WTC 1 collapse.

First, there was no visible abnormal loading locally applied to cause a local failure at the East Penthouse. The photograph in Fig. L–21 shows the east penthouse sustained no damage due to the collapse of the WTC towers. The videographic records do not show any visible fire in or near the penthouse prior to collapse.

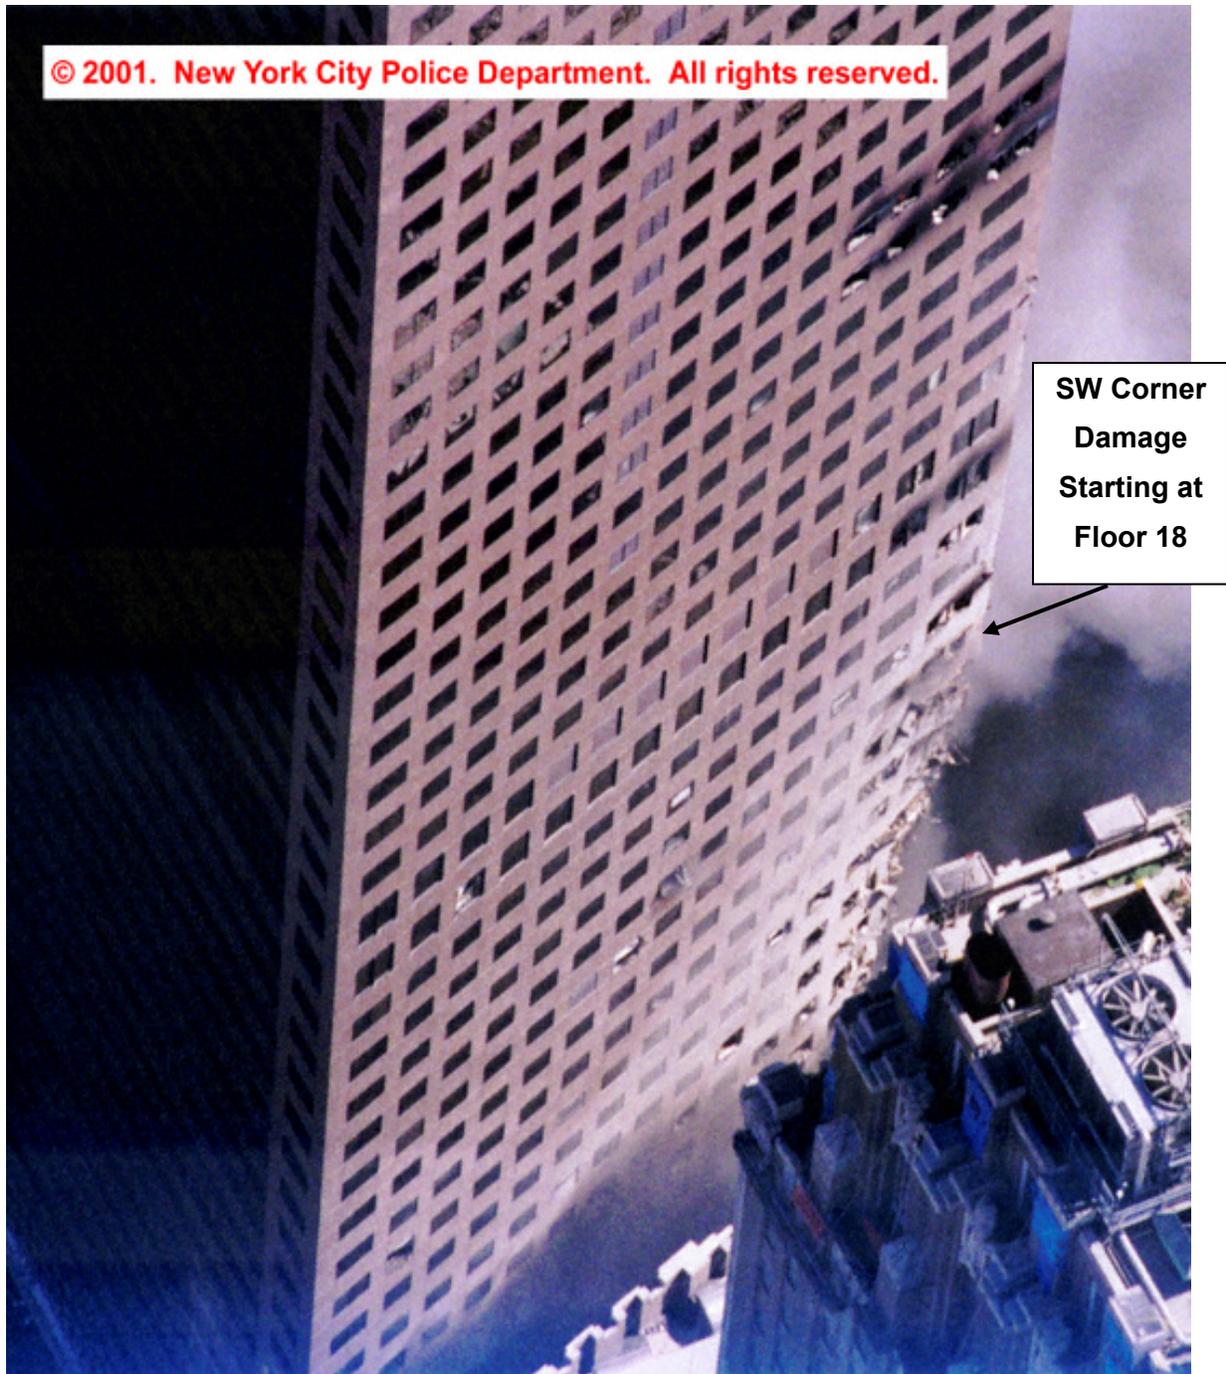
Figure L-22a. Debris damage around Floor 18 of the southwest corner.

- Figures L-22a shows fires that had burned out by early afternoon on Floors 19, 21, 22, 29, and 30 along the west face near the southwest corner.

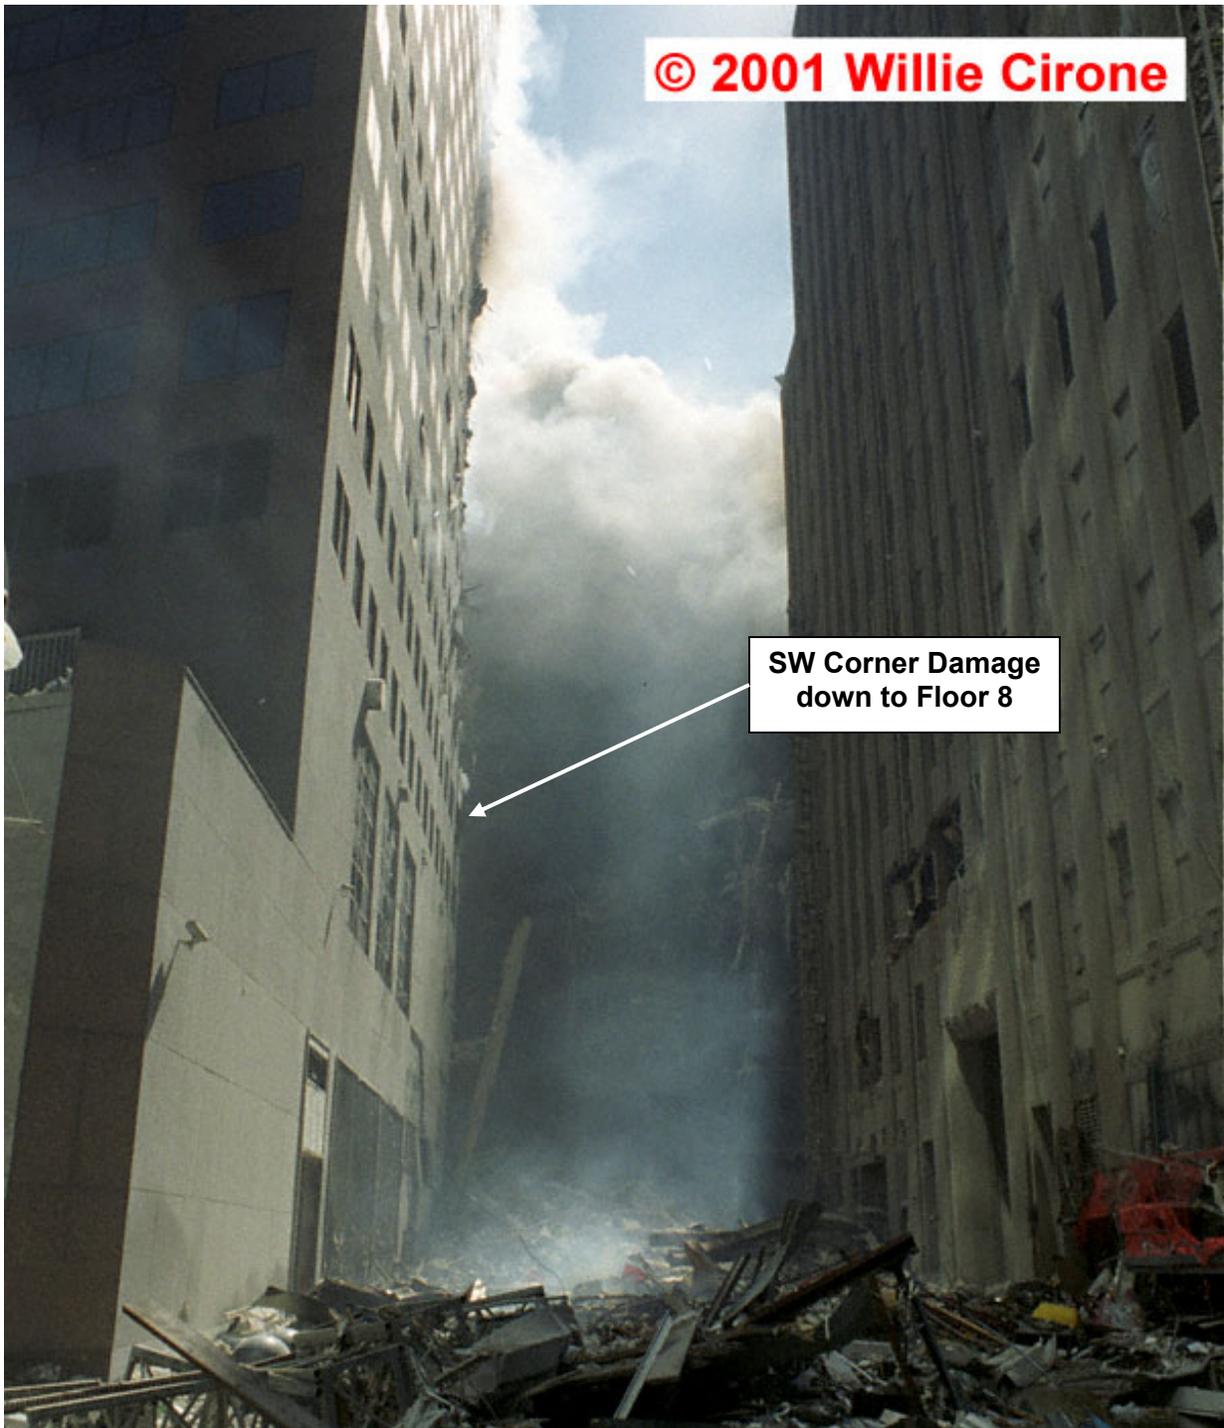
Figure L-22b. Debris damage around Floor 8 of the southwest corner.

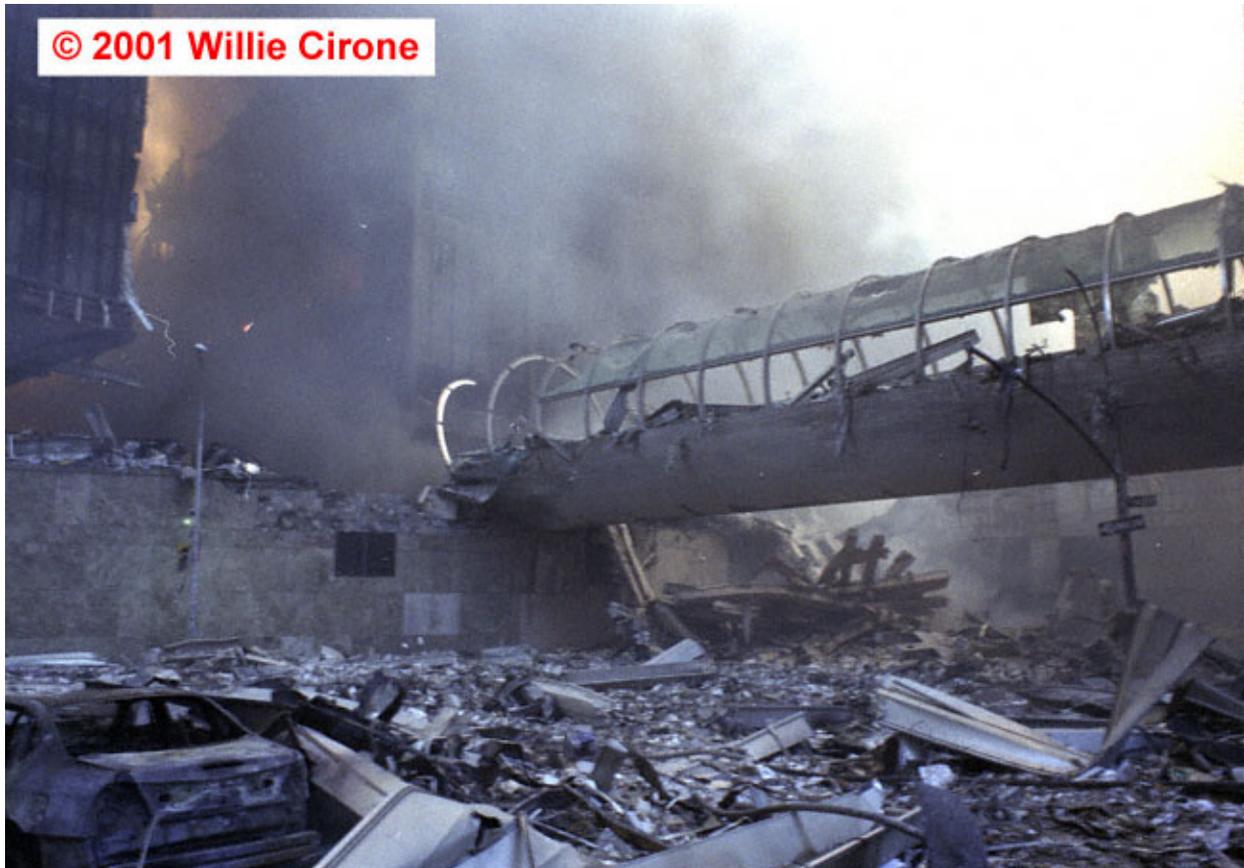
Figure L-23a. Pedestrian bridge and debris on Vesey Street after WTC 1 collapsed.

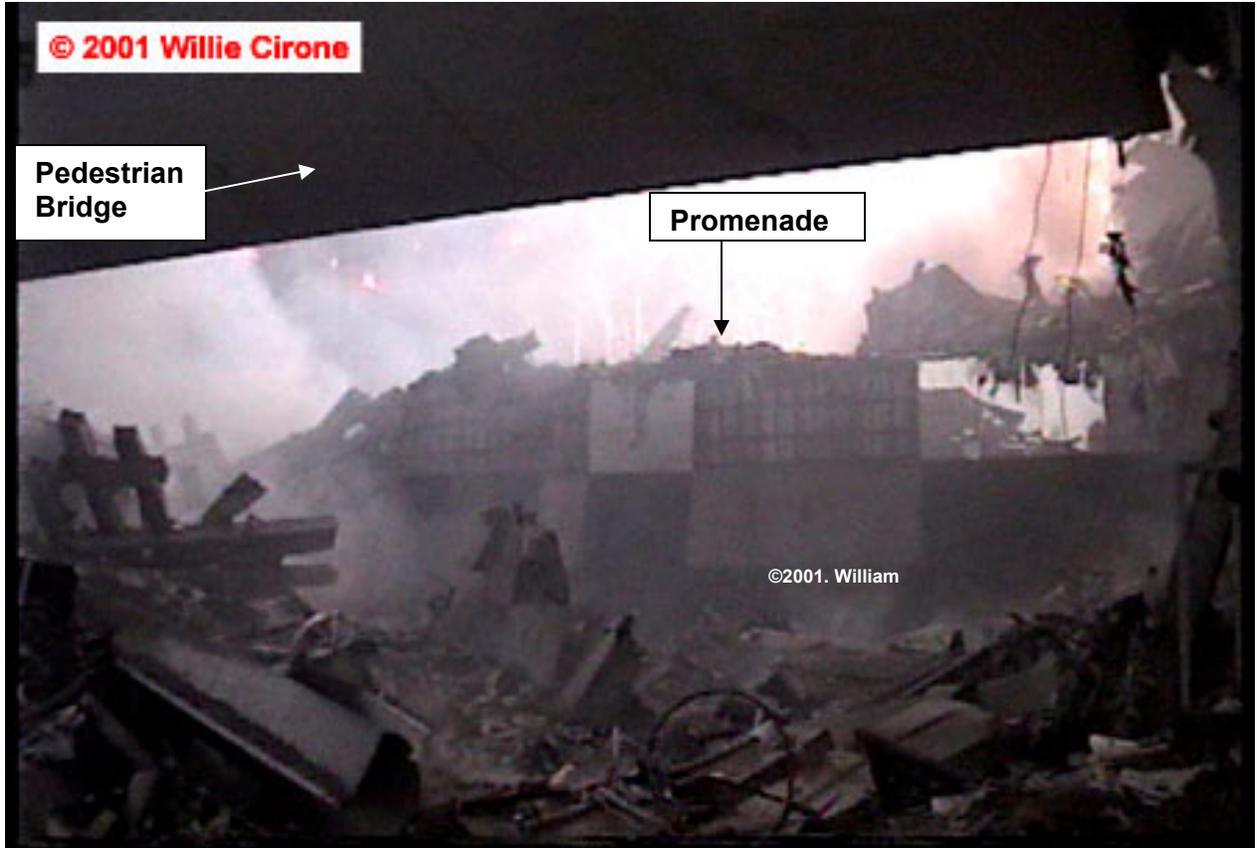
promenade (L-23b) appear to be standing, although damaged. Exterior panels from WTC 1 can be seen on Vesey Street and on the promenade. The approximate extent of possible damage due to debris from WTC 1 is shown in Fig. L-23c.

Figure L-23b. WTC 7 Promenade and debris on Vesey Street after WTC 1 collapsed.

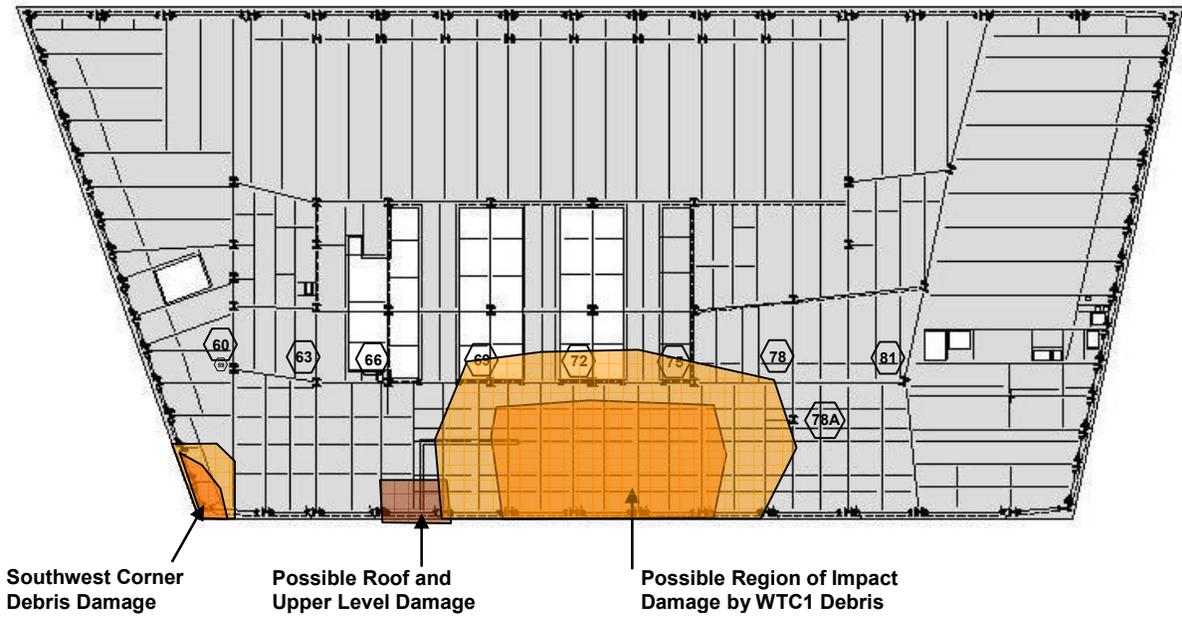
Figure L-23c. Possible extent of debris damage in plan.

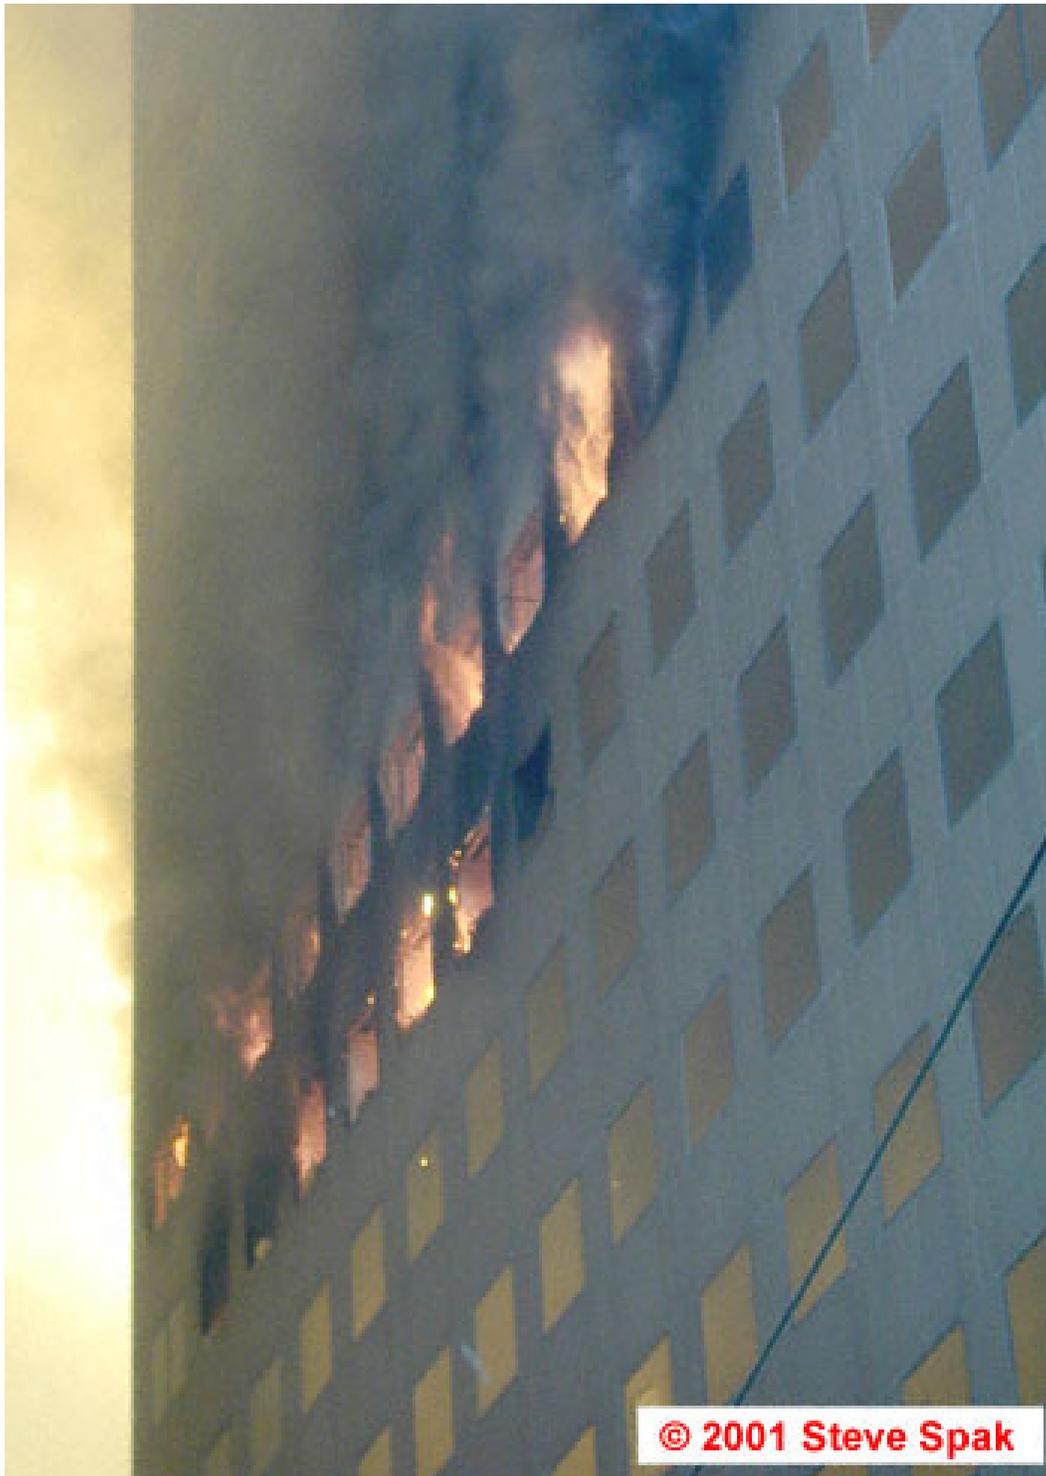
Figure L-24a. Fires on Floors 11 and 12 on the east face.

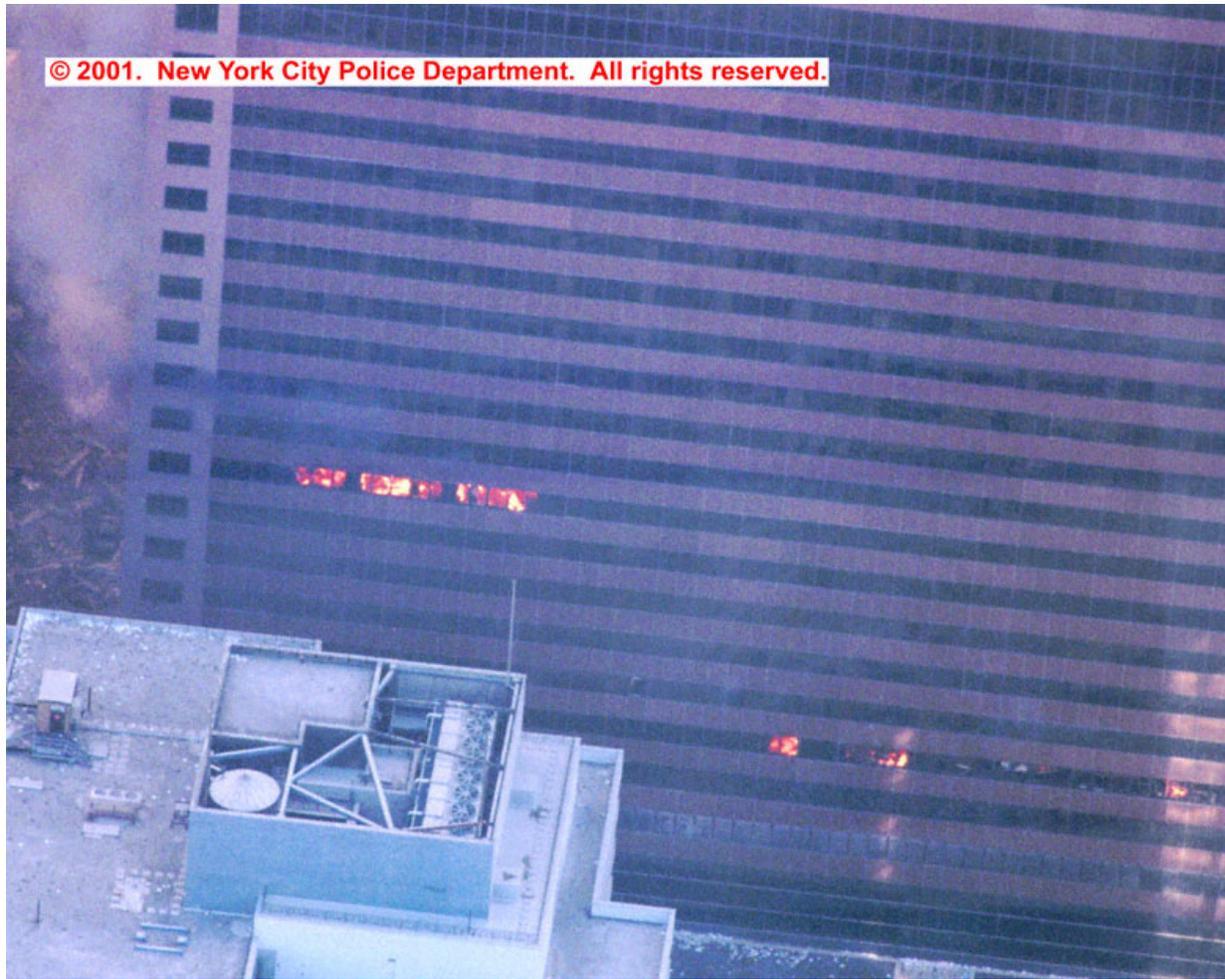
- Around 3 p.m., fires were observed on Floors 7 and 12 along the north face. The fire on Floor 12 appeared to bypass the northeast corner and was first observed at a point approximately one third of the width from the northeast corner, and then spread both east and west across the north face.
- Some time later, fires were observed on Floors 8 and 13, with the fire on Floor 8 moving from west to east and the fire on Floor 13 moving from east to west. Figure L-24b shows fires on Floors 7 and 12.
- At this time, the fire on Floor 7 appeared to have stopped progressing near the middle of the north face.

Figure L-24b. Fires on Floors 7 and 12 on the north face.

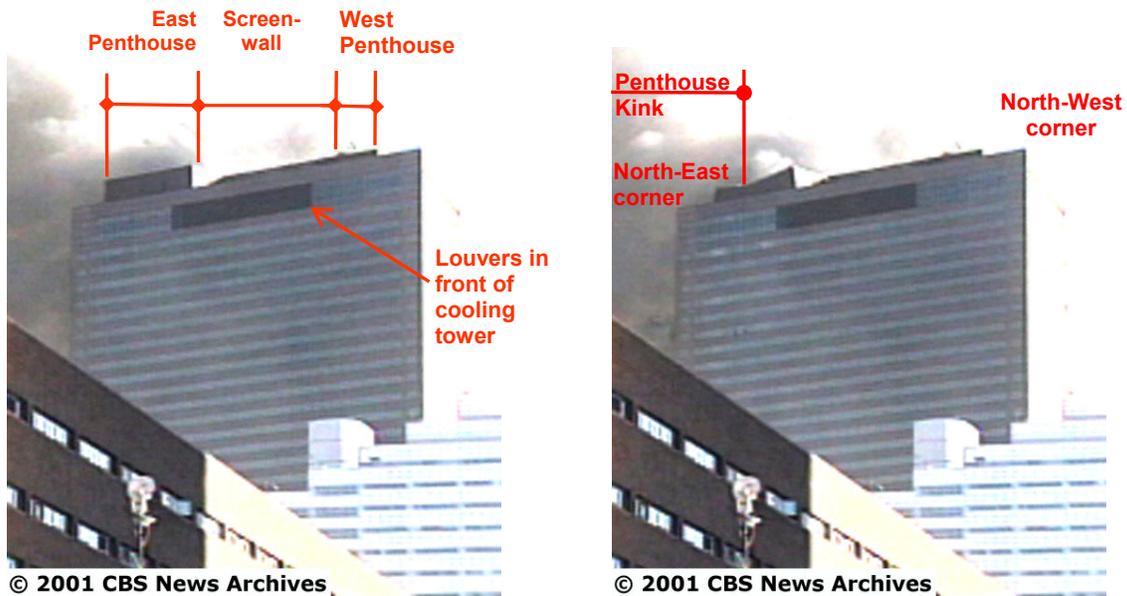
Figure L-25. East penthouse kink.

Second, Fig. L–25 shows a snapshot as the east penthouse starts to collapse. When the roof of the penthouse starts to fall, a line of windows (roughly in line with columns 79 to 81) has broken over the entire height of the visible region. In free fall, it would take 3 to 4 seconds for an object to fall from the roof elevation to the height of the bottom visible broken window, around Floor 33. Since the bottom window is broken nearly simultaneously when the kink is seen at the east penthouse, the initial failure may be assumed to have propagated upward from the lowest window breakage rather than propagated downward from the top of the building. Therefore, initial failure within the penthouse may be considered unlikely.

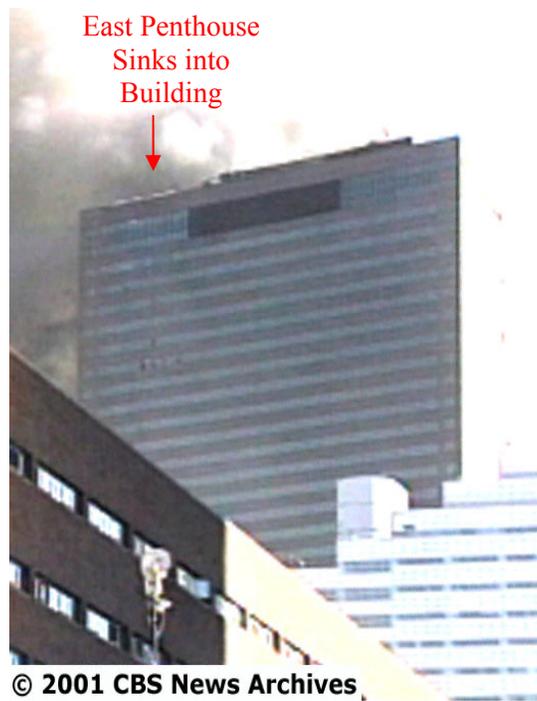
Figure L-26. East penthouse sinks (2.2 s).

Interior columns 79, 80, and 81, were located directly below the east penthouse on the roof and supported large tributary areas. It appears that some sequence of component failures in the region identified in Figs. L–29 and L–30 led to the failure of one or more of these columns, as discussed above. The failure progressed vertically upward within the failed bay to the roof level, based upon observations of window breakage relative to failure of rooftop structures, and was first visible from the exterior when the east penthouse lost support (see Fig. L–26).

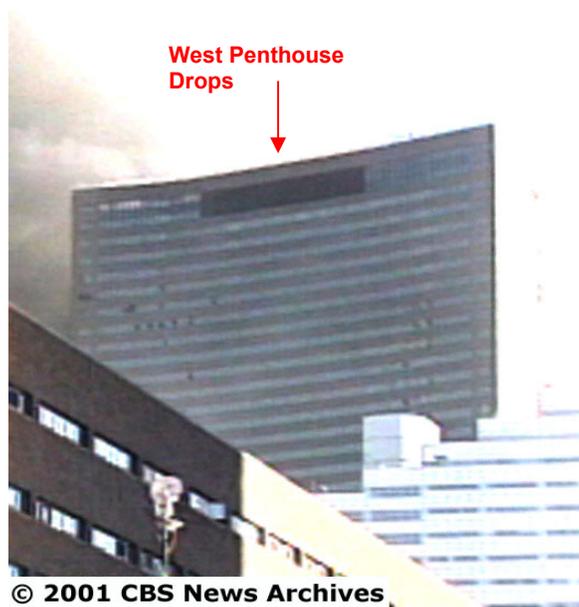
Figure L-27. Center screenwall and west penthouse sink (7.9 s).

The 5 s to 6 s delay between the failure of the east penthouse and the failure of the screenwall and west penthouse (shown in Fig. L-27) approximates the time it would take for the debris pile from the vertical failure progression on the east side of the building to reach Floors 5 to 7 and damage the transfer trusses and girders in this area.

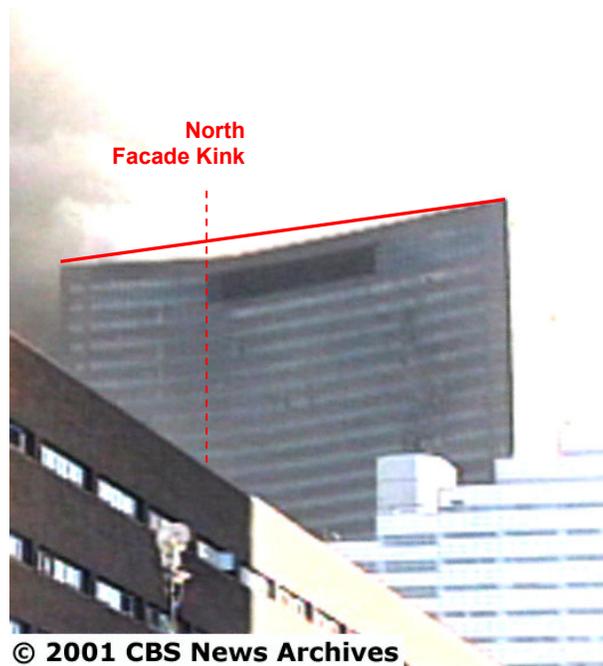
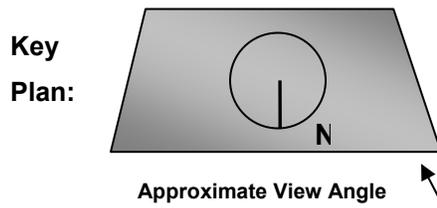
Figure L-28. Global collapse.

The simultaneous failure of screenwall and west penthouse structures, window breakage on the west side of the north facade, and initiation of global collapse (see Fig. L-28) indicates that the building loads could no longer be supported. Horizontal progression of the collapse appears to have occurred after the vertical collapse on the east side of the building. The greater strength of Floors 5 and 7 relative to the other floors and the transfer trusses between these floors suggests that this region of the building played a key role in destabilizing the remaining core columns, and the global collapse occurred with few external signs prior to the system failure.

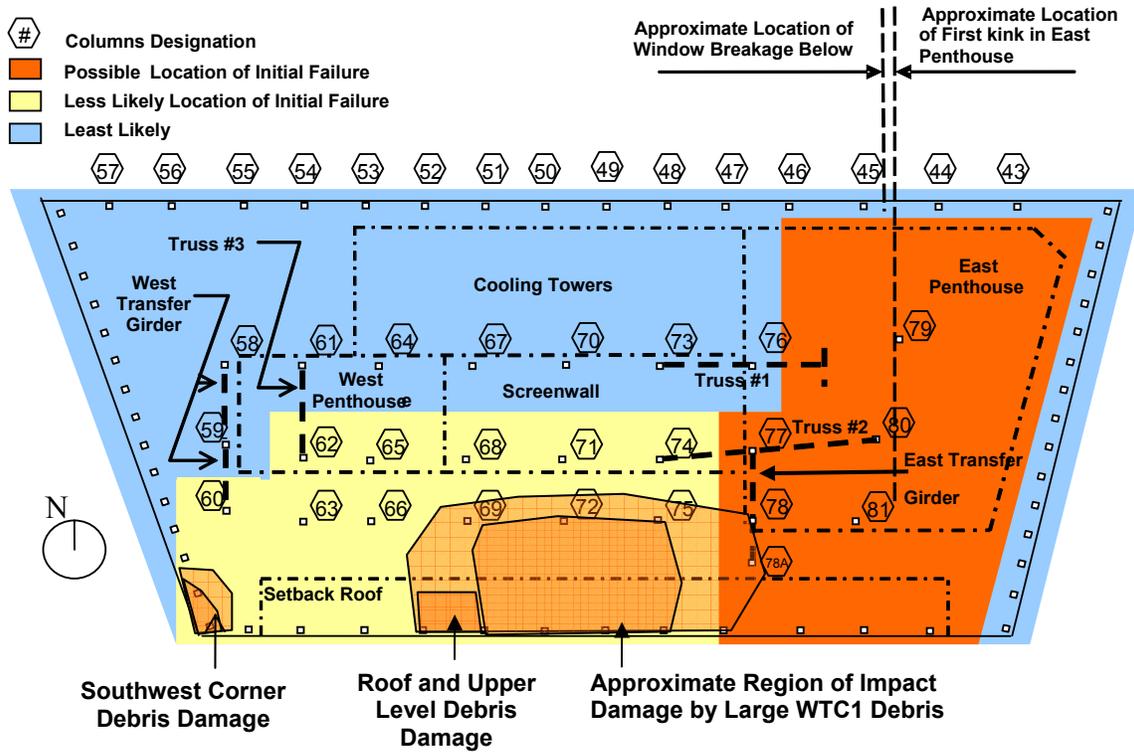
Based on review of the photographic and videographic records, a failure of any column within the plan area shown in Fig. L–29, and below Floor 13, likely contributed to the collapse initiation. This includes columns 76, 77, 78, 79, 80, and 81, truss #1, truss #2, column 78A, the east transfer girder and adjacent framing and floor systems within this region (see Fig. L–30).

Figure L-29. Plan view of regions for collapse initiation.

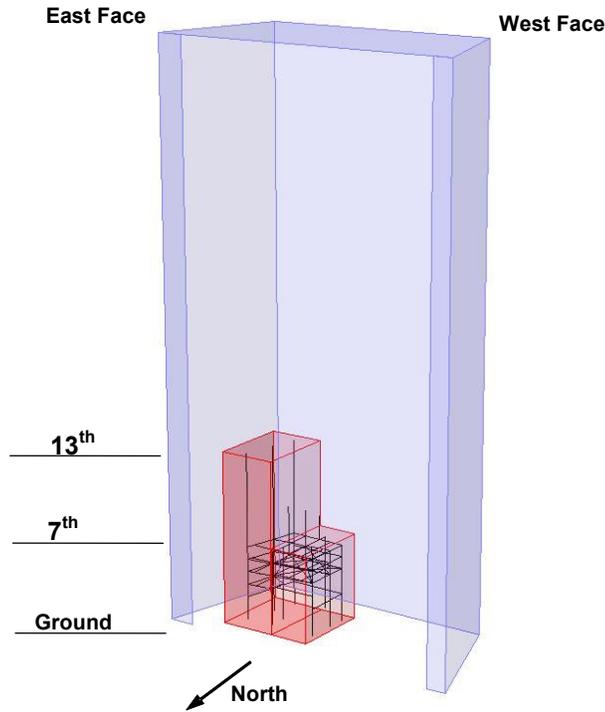
Figure L-30. Likely region of initiating component failures based on videographic and photographic records of fire and collapse.

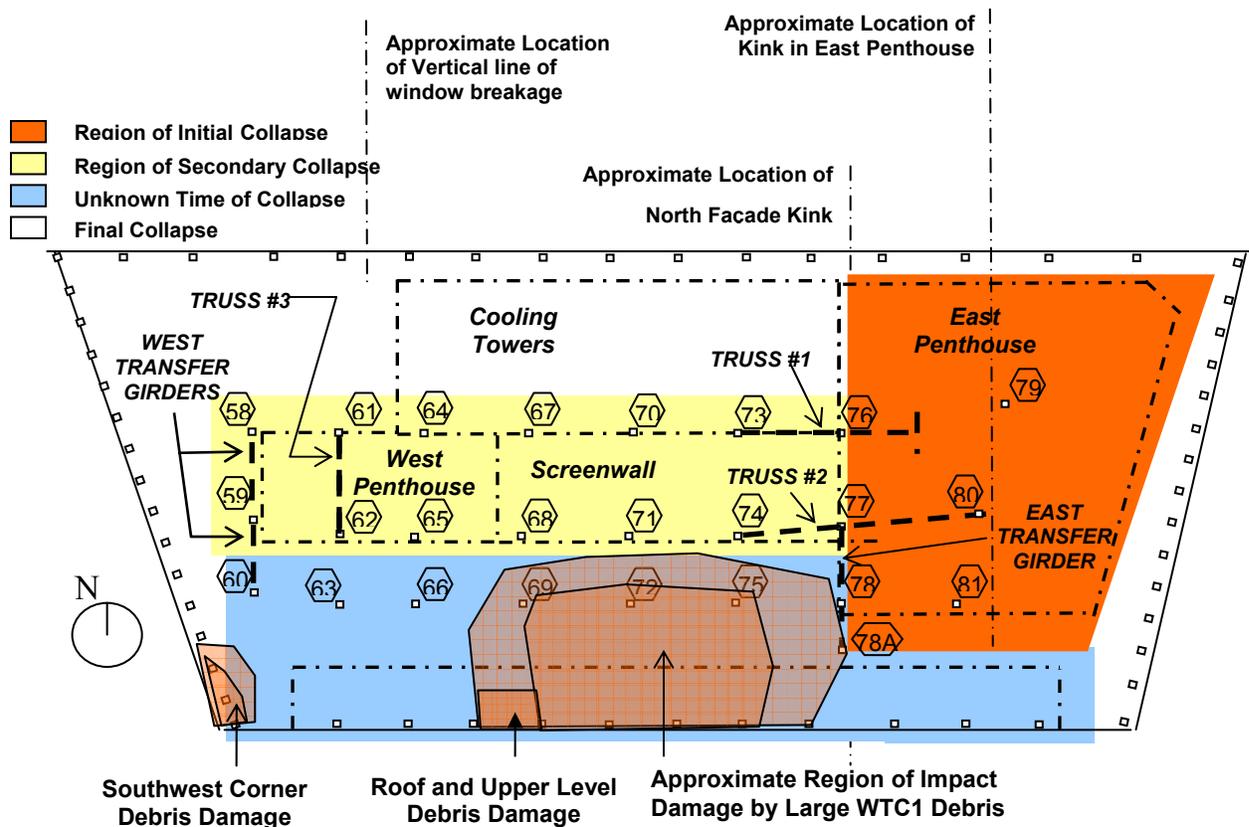
When the screenwall and the west penthouse sank into the building, a line of windows broke from Floor 44 down to the bottom of the visible range, which is approximately at Floor 33 on the west side of the structure (see Fig. L-27). This area aligns with column 61, which is supported by the cantilevered end of transfer truss #3 between Floors 5 and 7, as shown in Fig. L-31. This suggests that the observed window breakage may be related to the failure of column 61 or truss #3.

Figure L-31. Plan View of Collapse Progression.

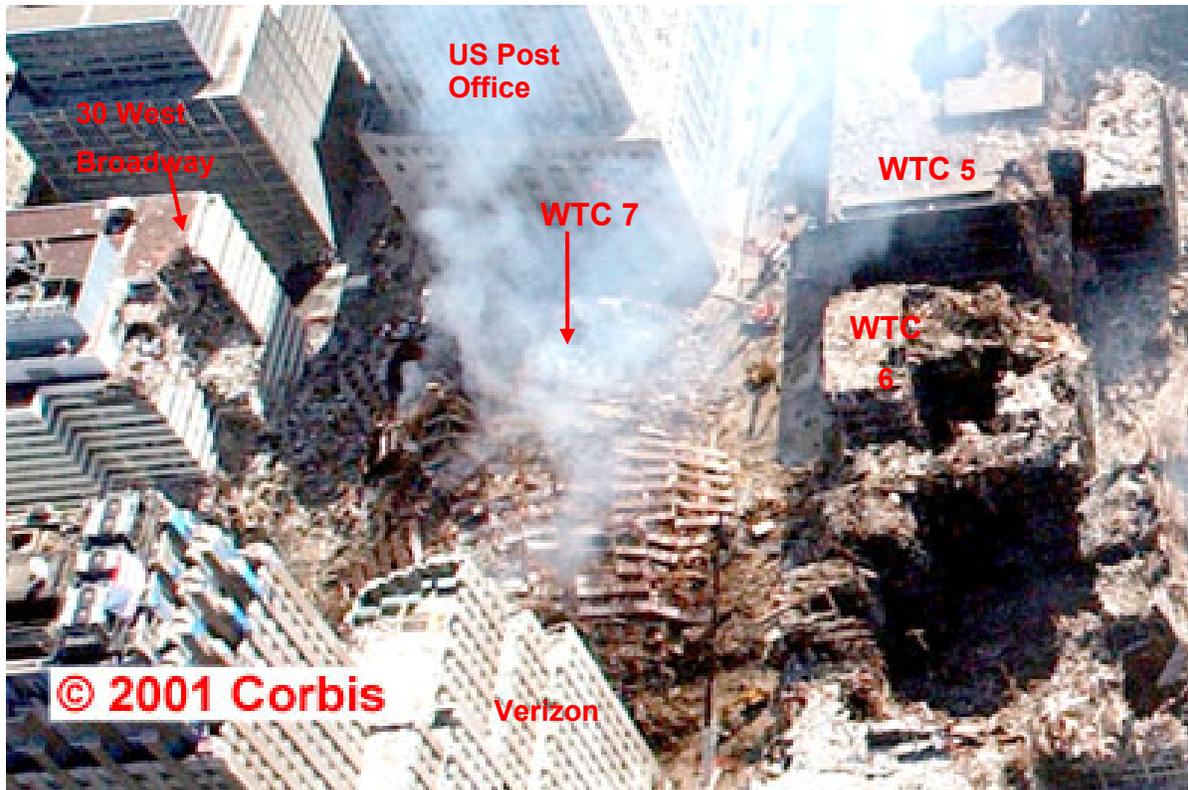
The debris of WTC 7 was mostly contained within the original footprint of the building. From aerial photos, the debris visible on top of the pile is mostly façade structure. This failure sequence suggests that the interior of the building collapsed before the exterior. See Fig. L-32.

- The relatively small debris field, with the exterior moment frame visible on top of the building debris, an internal collapse mechanism is likely.

Figure L–32. Aerial view of WTC 7 after collapse.

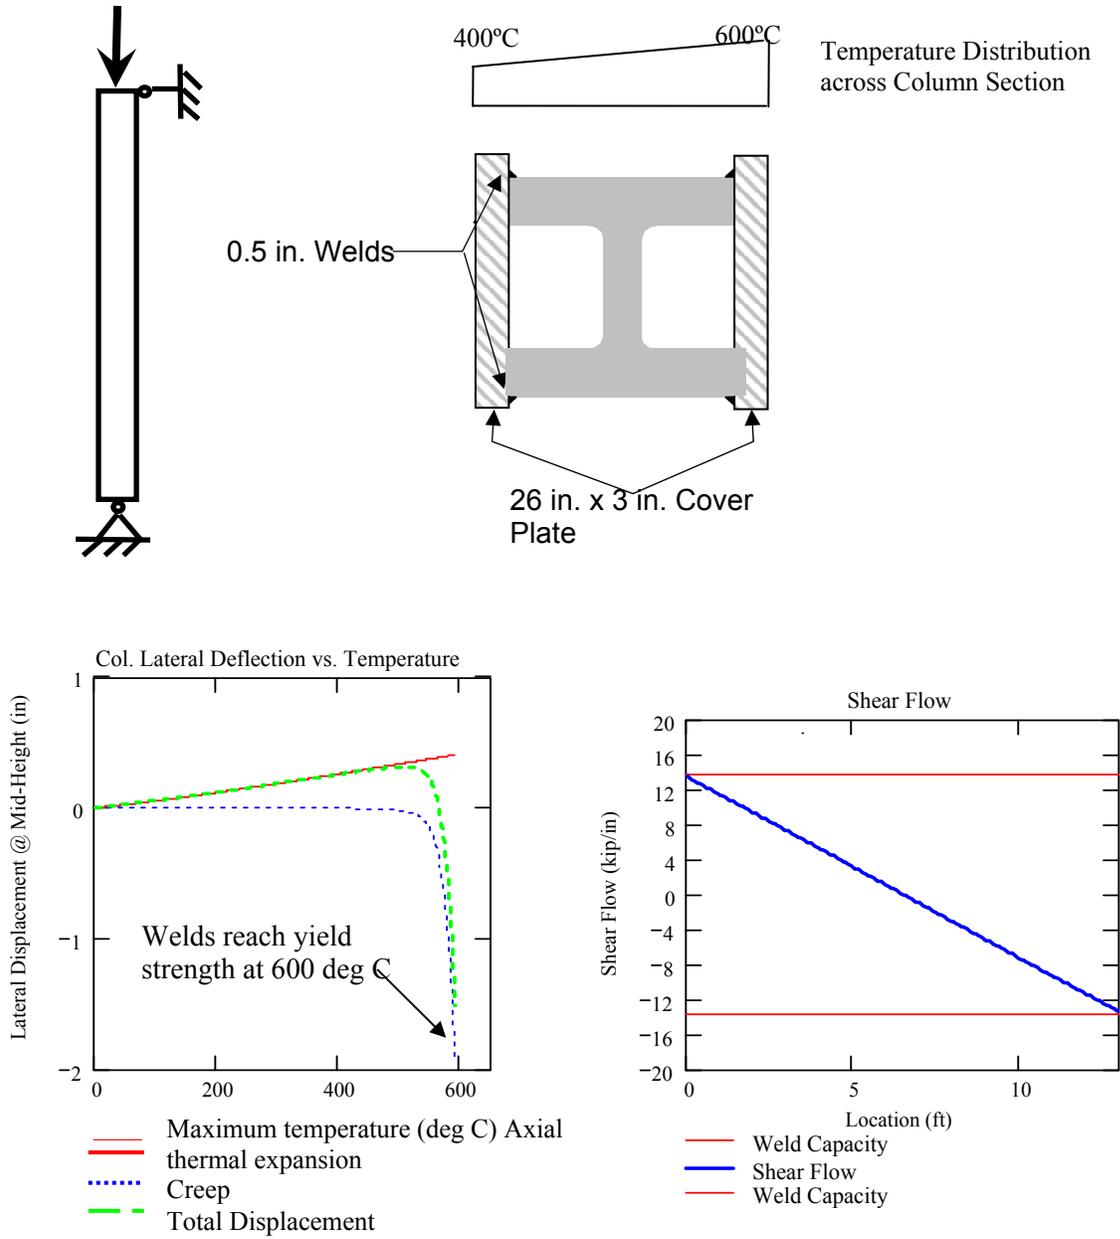
- **I4.5 Temperature Gradients:** Fire effects may have caused the failure of columns and other components through the forces induced by temperature gradients through their cross section. Bending and shear forces may be induced that are sufficient to yield either the column splice or reinforcing plate welds. Analysis of a one-story segment of interior column 79 indicates that the cover plate weld would begin to yield at a mean temperature of 490 °C with a 200 °C gradient across the section, as shown in Fig. L-38. Other mean temperature and gradient combinations may also cause this type of failure.

Figure L-38. Effects of temperature gradient on interior column 79.

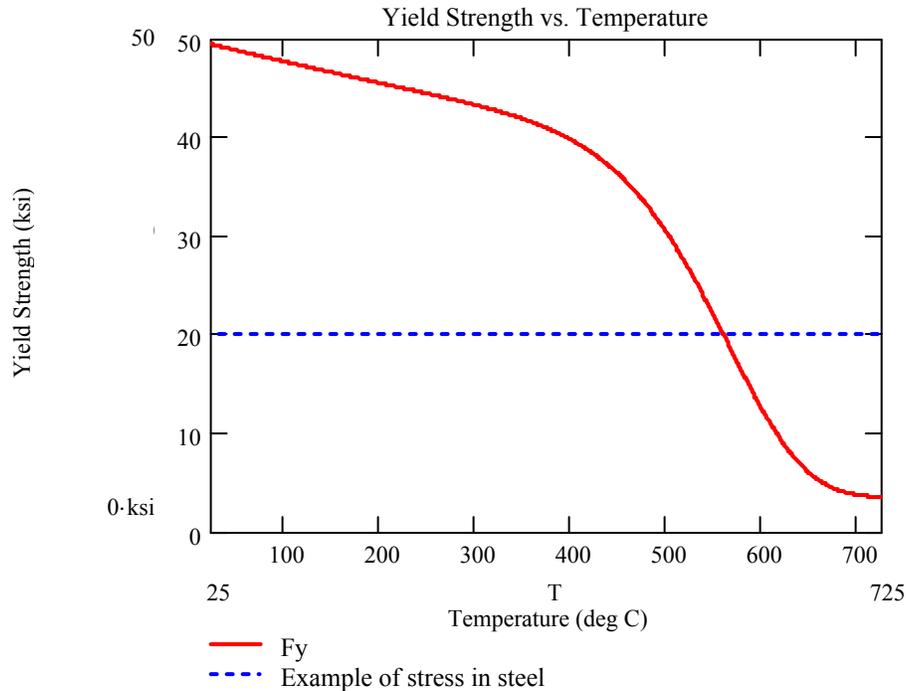
- **I4.6 Uniform High Temperatures:** If initiating event components were sufficiently exposed to fire effects to be uniformly heated to elevated temperatures, the steel strength would be reduced below that required to support the load. Figure L-39 shows that for interior columns subject to service loads (shown as approximately 20 ksi of compressive stress), uniform steel temperatures of approximately 570 °C would result in column failure.

Figure L-39. Steel strength versus temperature.

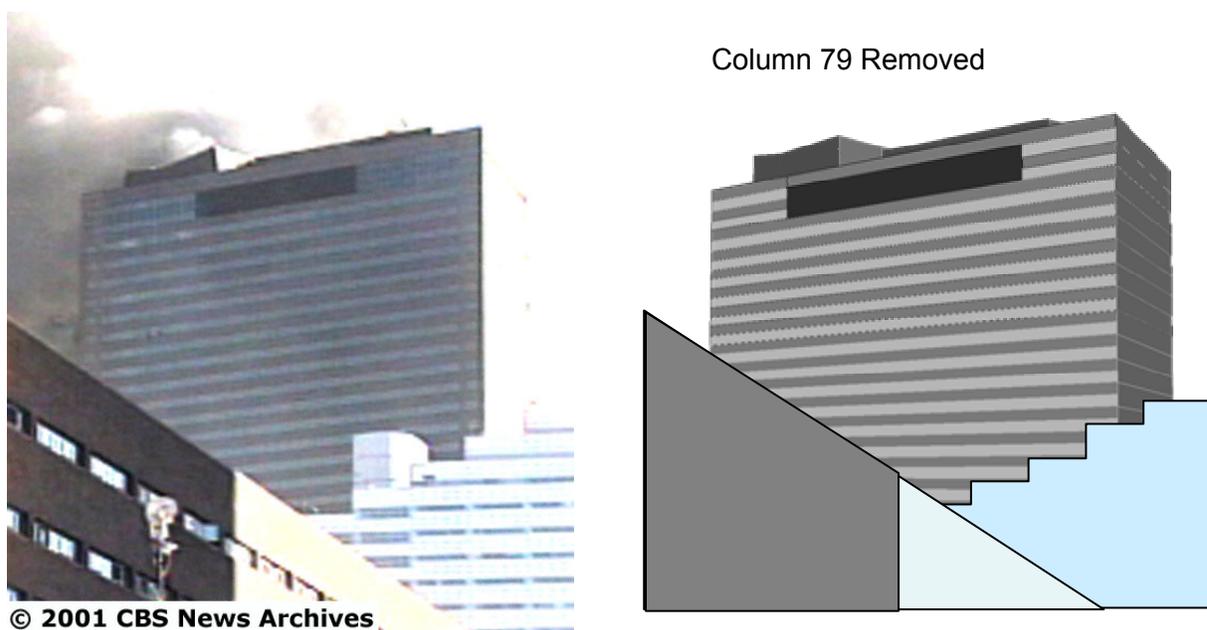
- **V3.4 East Penthouse Collapses Differently than Observed:** The collapse could have progressed upwards, but the failure caused in the east penthouse could be different than what was actually observed.
- **V3.5 East Penthouse Collapses as Observed:** Had the failure of the column progressed upwards, then it could have been reflected in the observed collapse of the east penthouse, which sits directly above columns 79, 80, and 81. Also, the kink observed in the roof of the east penthouse was in line with these columns. A collapse mechanism analysis performed for the removal of column 79 produced a deformed shape with a kink in the roof of the east penthouse (see Fig. L-45). This is a possible collapse scenario.

Figure L-45. Geometry change for removal of column 79.

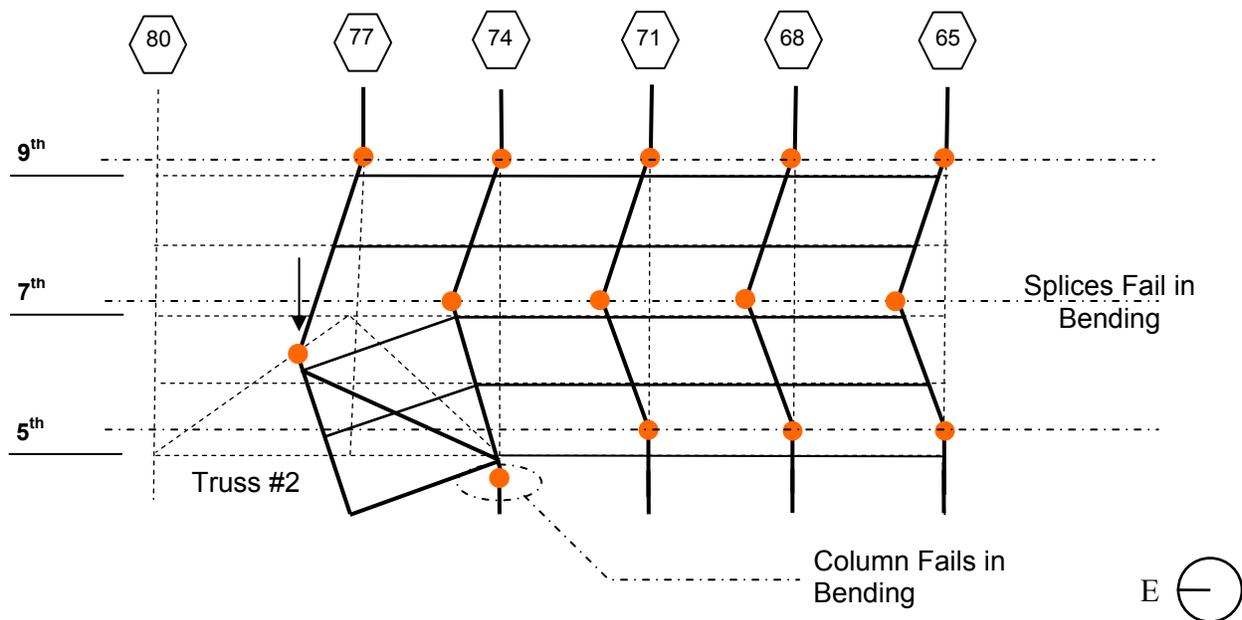
- **H2.6 Collapse Does Not Progress:** The Floor 7 slab may fail at adjacent columns prior to imposing lateral displacements sufficient to fail the columns or their splices.
- **H2.7 Collapse Progresses:** The horizontal tensile force would tend to pull the line of columns 74, 71, 68, 65, and 62 towards the east. The general absence of the Floor 7 slab and braced frames around the center core column line, due to the presence of elevators shafts, creates a more likely scenario for the simultaneous lateral displacement of the center core columns without similarly displacing other core columns. The possible result is a failure of all the columns at their splices, as shown in Fig. L-49.

Figure L-49. Horizontal progression mechanism for truss #2 failure.
