Appendix L

Interim Report on WTC 7	L–1
L.1 Building Description	L–1
L.1.1 Purpose	L–1
L.1.2 Scope of Work	L–1
L.1.3 Introduction	L–1
L.1.4 Foundations	L–3
L.1.5 Con Edison Substation	L–4
L.1.6 Floor Systems	L–5
L.1.7 Columns	L–13
L.1.8 Column Transfer Trusses and Girders	L–14
L.1.9 Lateral System	L–15
L.2 Observations of Structural Collapse	L–17
L.2.1 Damage from WTC 1 and WTC 2 Collapses	L–17
L.2.2 Observed Fire Locations	L–22
L.2.3 WTC 7 Collapse Observations	L–26
L.2.4 Interpretation of Collapse Initiation Observations in Elevation	L–29
L.2.5 Interpretation of Collapse Progression Observations	L–30
L.2.6 Debris Field	L–33
L.2.7 Summary	L–33
L.3 Collapse Hypothesis	L–34
L.3.1 Introduction	L–34
L.3.2 Collapse Initiation Scenarios	L–36
L.3.3 Vertical Progression Scenarios	L–41
L.3.4 Horizontal Progression Scenarios	L–46
L.3.5 Summary of Working Collapse Hypothesis	L–50
L.3.6 Technical Approach for Analysis of the Working Collapse Hypothesis	L–52

Project 6 addresses the first primary objective of the technical investigation led by the National Institute of Standards and Technology (NIST) of the 47-story World Trade Center (WTC) disaster: to determine why and how WTC 7 collapsed. S

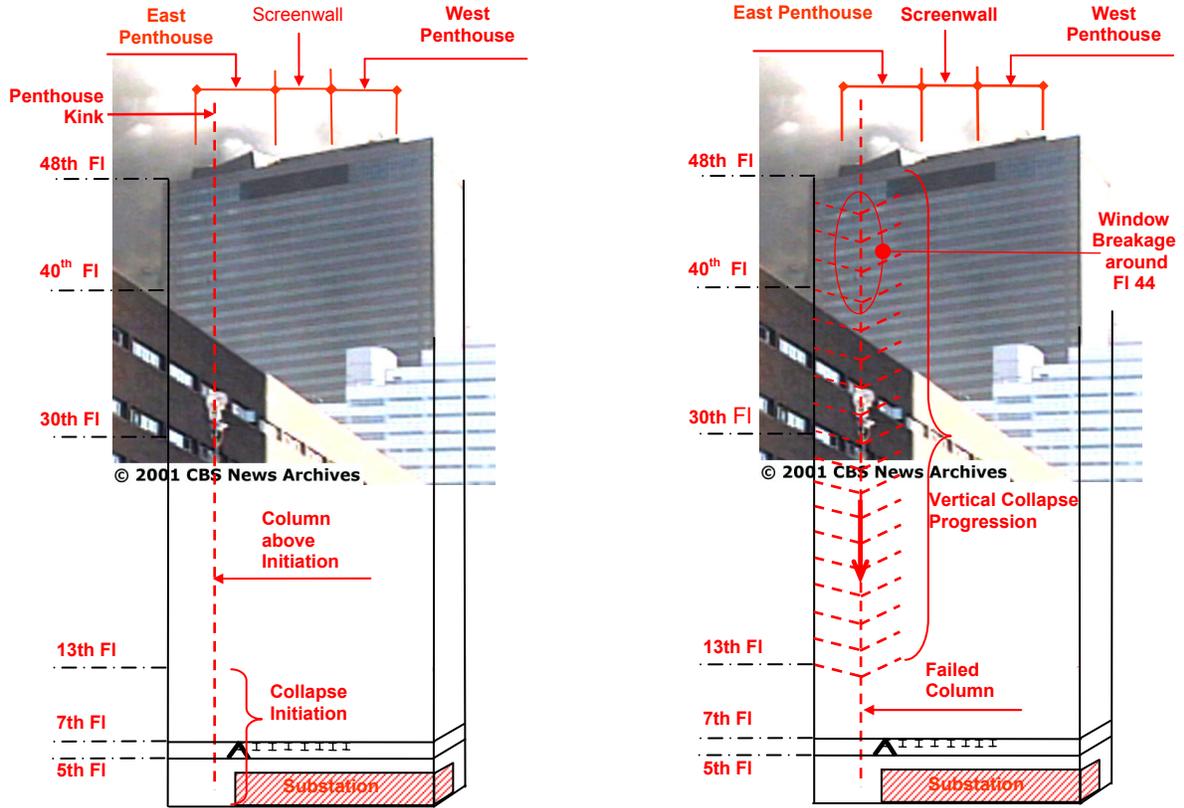
Figure L-33. Collapse initiation and vertical progression on the east side of WTC 7.

To develop a working hypothesis for the collapse sequence, it is useful to subdivide the problem into several phases. Many factors and structural components may have contributed to the start of the collapse, but there must have been an initiating event. After the collapse initiated, it progressed to other parts of the building, leading to their failure as well. From the observations of the collapse (see Section L.2), it appears that first there was a vertical failure progression, from some point in the lower eastern portion of the building up to the east penthouse. After a time lag of approximately five seconds, the screenwall and west penthouse were observed to begin sinking into the core area. This suggests that there was a horizontal progression of the collapse towards the west. Since the screenwall and west penthouse fell almost simultaneously, it is reasonable to assume that the horizontal progression captured all the columns that support these building parts.

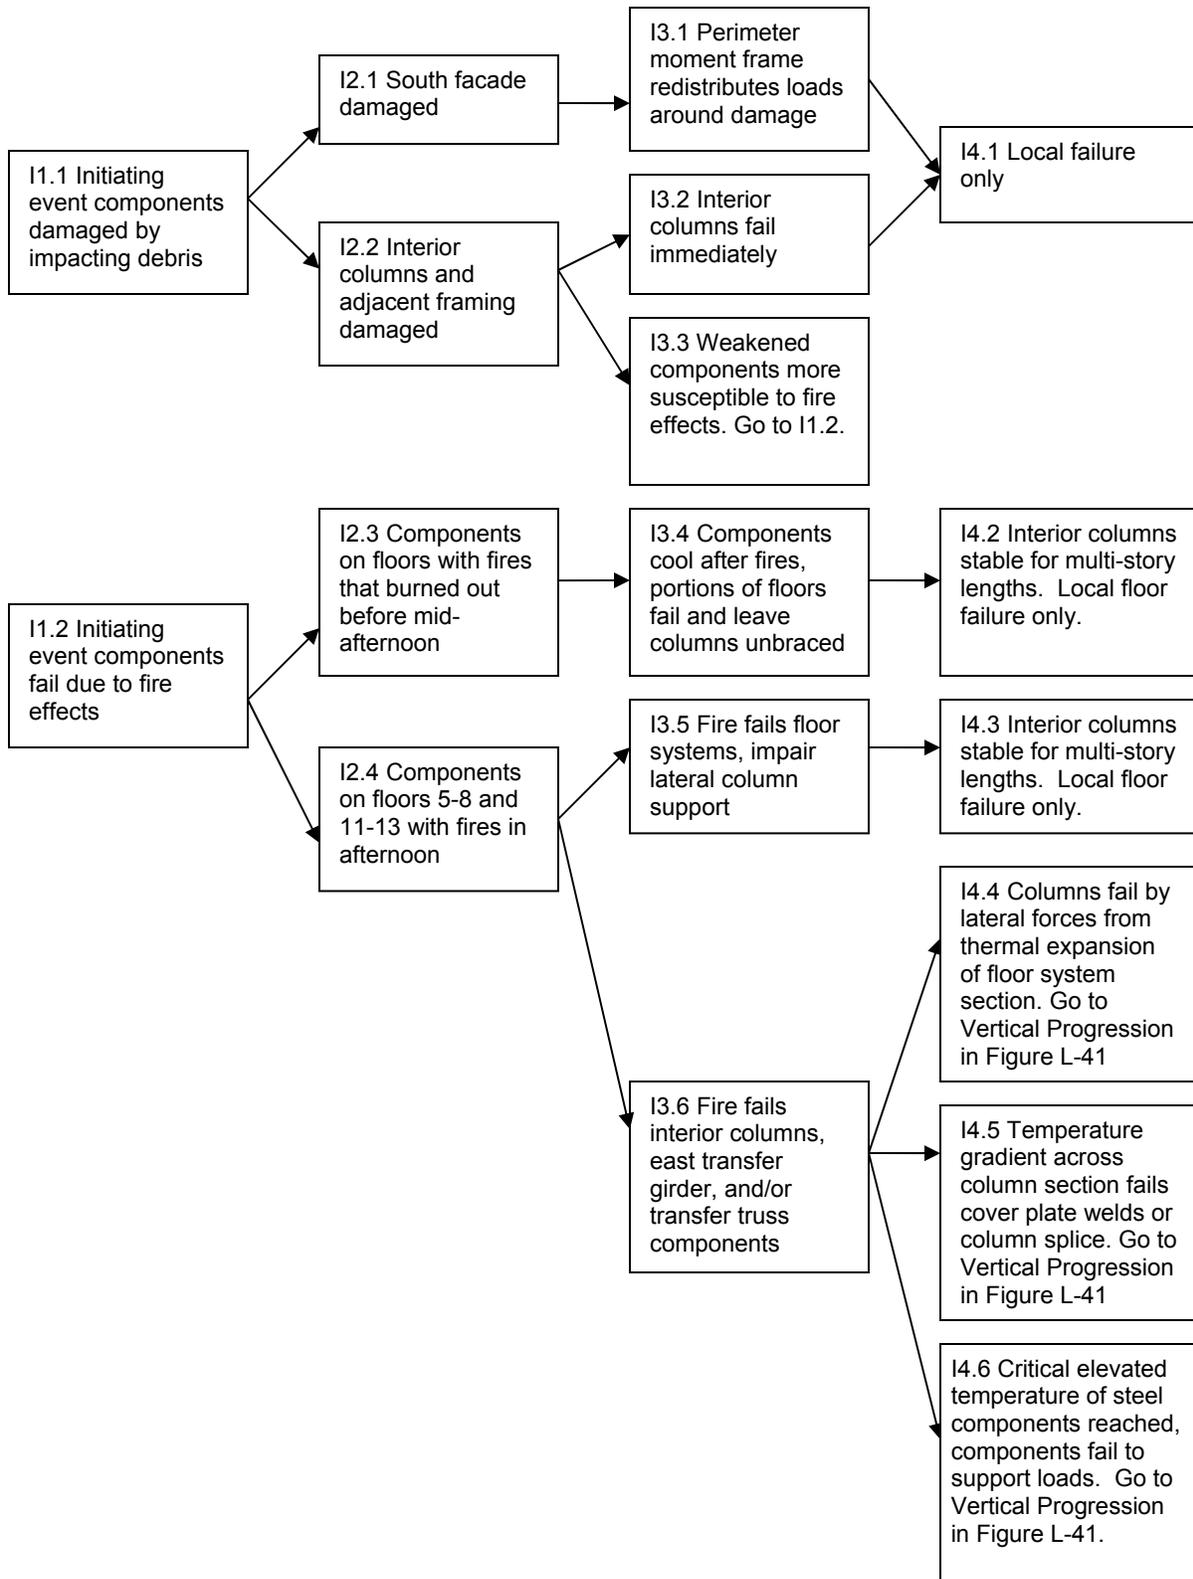
Figure L-36. Collapse initiation scenarios.

- **I3.1 Perimeter Moment Frame Arrests Failure Progression:** Analysis of the global structure indicates that the structure redistributed loads around the severed and damaged areas. A progression of column failure to adjacent columns would have been arrested by the vierendeel action of the perimeter moment frame, which could span across a sizeable opening due to the strength and stiffness of the frame.

- **I2.2 Debris Damage to Interior Columns:** Interior columns may have been severed or damaged by impacting debris.
 - **I3.2 Interior Columns Fail Immediately:** If interior columns had been severed or severely deformed, they may have failed immediately.

- **I4.1 Localized Failure at Interior Columns:** If the interior columns failed just after impact, this likely resulted in a local failure only, since the building continued to stand for almost 7 hours after WTC 1 collapsed. This failure could have progressed vertically upward to the roof level within the bays immediately adjacent to the failed columns, yet from the northern vantage point of the photographic and videographic observations, would not have been visible.
- **I3.3 Interior Columns Remain Standing But Damaged:** If interior columns were weakened by damage from debris, but retained sufficient capacity to carry their loads, then additional loading and/or fire effects would have been required to cause their failure. Debris impact may have damaged the structural steel fireproofing without significantly deforming the structural component.

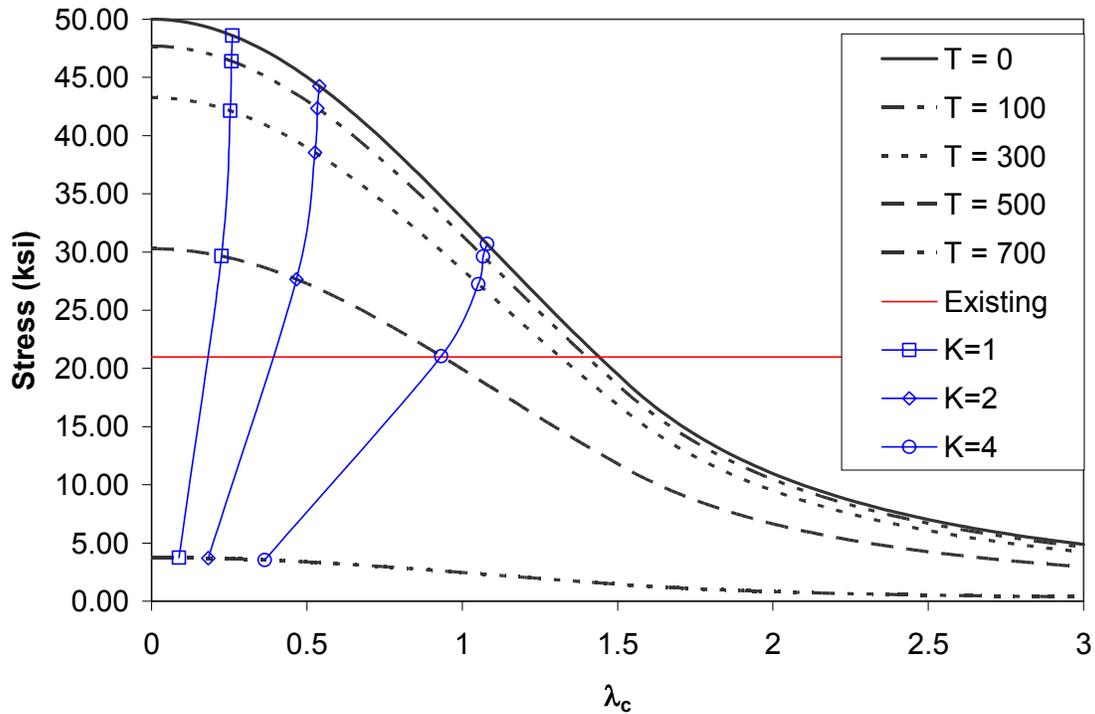
Figure L-37. Column 79 capacity versus temperature and unbraced length K.

- **I4.3 Unbraced Columns:** If floor systems failed, one or more columns may have lost lateral bracing. See I4.2 for discussion.
- **I3.6 Columns, Transfer Girders or Transfer Trusses Fail:** The fires could have failed interior columns, transfer girders, transfer trusses, or their framing connections.

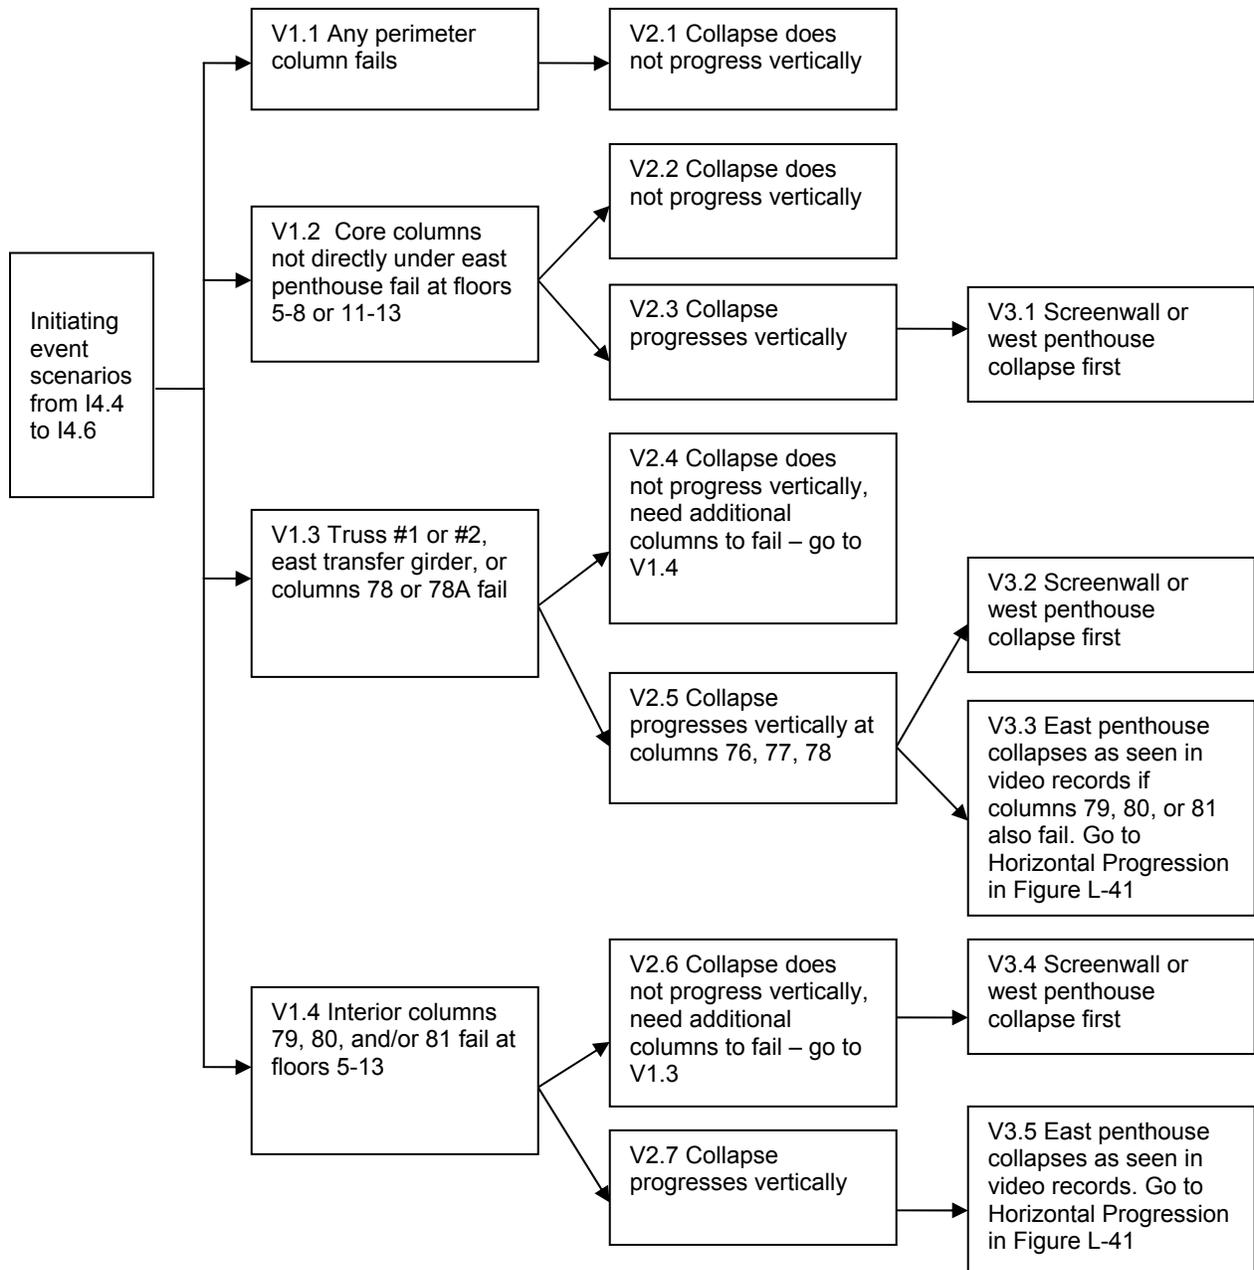
Figure L–40. Vertical collapse progression scenarios.

V1.2 Core Columns Not Directly under East Penthouse Fail: Had the initiating component been a core column that was not under the east penthouse, most likely it would have been at floor levels with debris impact damage (possible range extends from the ground level up to Floors 15 to 20) or the floors

possibly experiencing fire (Floors 5, 6, 7, 8, 9, 11, 12, or 13). However, a core column may have failed following the failure of adjacent columns or framing members.

- V2.2 Collapse Does not Progress:** If core columns failed, the loads above the failed columns may have been redistributed to adjacent columns through the core floor system. If the loads could not be redistributed, then additional failures in one or more components would have been necessary to progress the collapse.
- V2.3 Collapse Progresses:** From this initial failure, the portion of the column above the failure could have fallen, progressing the failure vertically upwards.

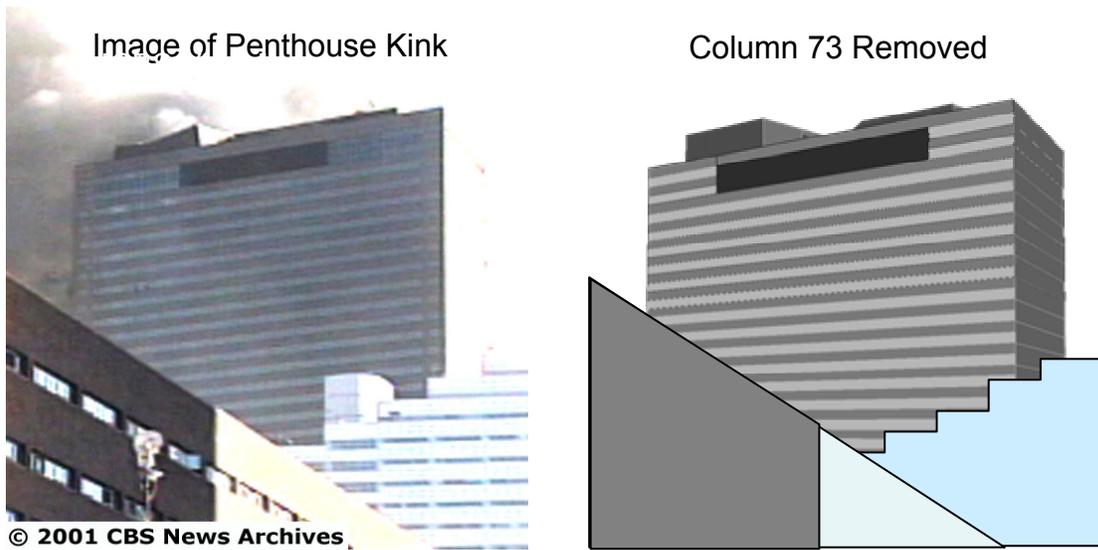
Figure L-41. Geometry changes for removal of column 73.

- V3.1 Something Else Besides East Penthouse Observed to Collapse First:** Had the failure of core columns progressed upwards, then the first exterior sign of the internal failure likely would have been seen in the screenwall or west penthouse, which are located above the core columns. A collapse mechanism analysis performed for the removal of columns 61, 64, 67, 70, and 73 produced geometry changes that differed from the observed collapse. For the scenario where each of these columns fails and the failure progresses upwards to the roof line as the adjacent floors cannot redistribute the loads, the screenwall or the west penthouse collapses, and no kink develops in the east penthouse (see Figs. L-41, L-42, and L-43).

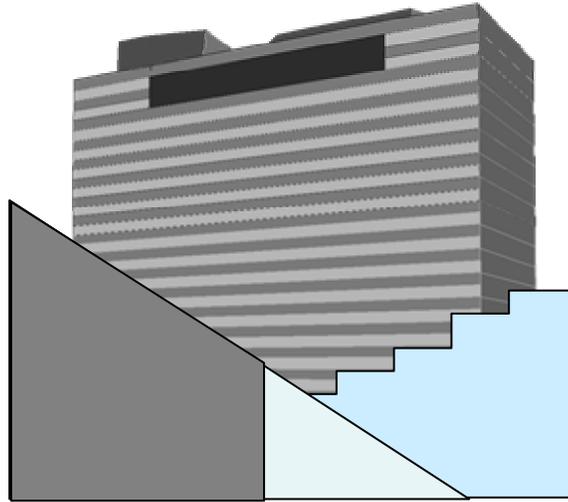
Figure L-44. Geometry changes for removal of column 76.

- **V3.2 East Penthouse Collapses Differently Than Observed:** If truss #1 or truss #2 failed and the failure progressed vertically upward to the roof level, the exterior deformations observed in the roof structures would be different from what was actually observed. Column 76 supported the west side of the east penthouse and the east end of the screenwall. A collapse mechanism analysis performed for the removal of column 76 produced a geometry change that shows the west side of the east penthouse and the east end of the screenwall deflecting downward (see Fig. L-44).

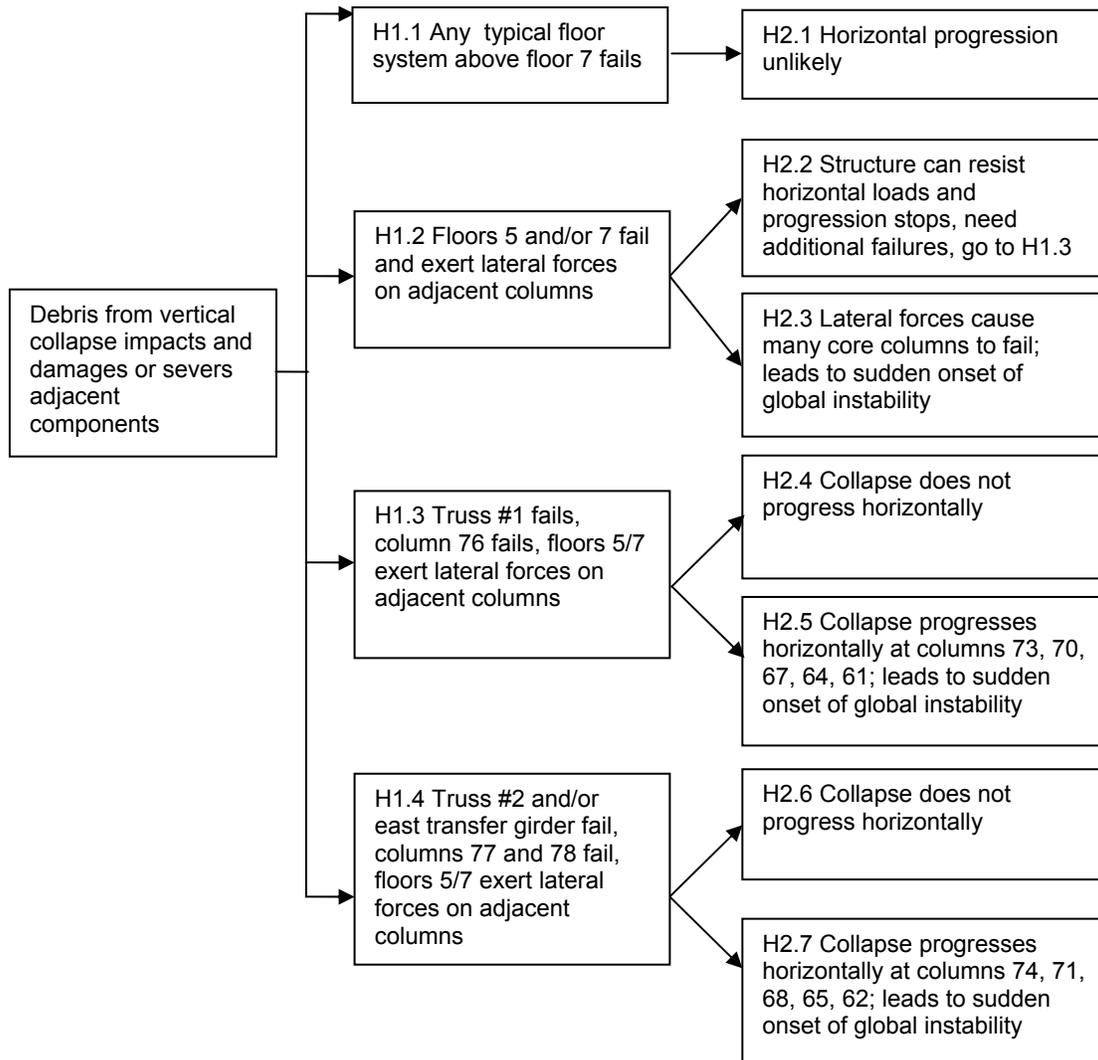
Figure L-46. Horizontal collapse progression scenarios.

After the east penthouse was observed to sink into the building core, approximately five seconds lapsed before the screenwall and west penthouse were observed to also sink into the building core. The screenwall and west penthouse movements occurred almost simultaneously with the global collapse of the structure. From these external observations, it appears that after the vertical progression failure on the east side of the building, the failure progressed horizontally across the core. The horizontal progression of the collapse could have started due to any of the likely vertical progression scenarios, which are shown in Fig. L-46.

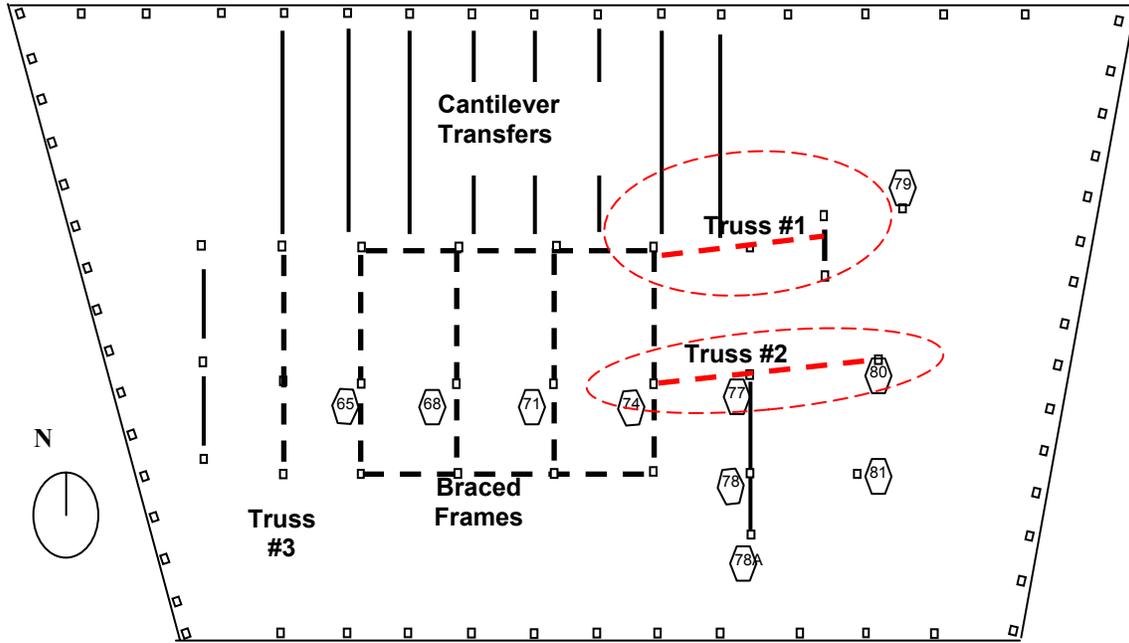
Figure L-47. Transfer components between Floors 5 and 7.

H1.3 Truss #1: If one of the diagonals of truss # 1 (see Fig. L-47) was damaged or severed by collapse debris from the vertical progression, there would be a horizontal force developed in the Floor 7 slab as column 76 became unstable. The floor beam between column 76 and column 73 would try to restrain column 76 movement through tensile forces to column 73.

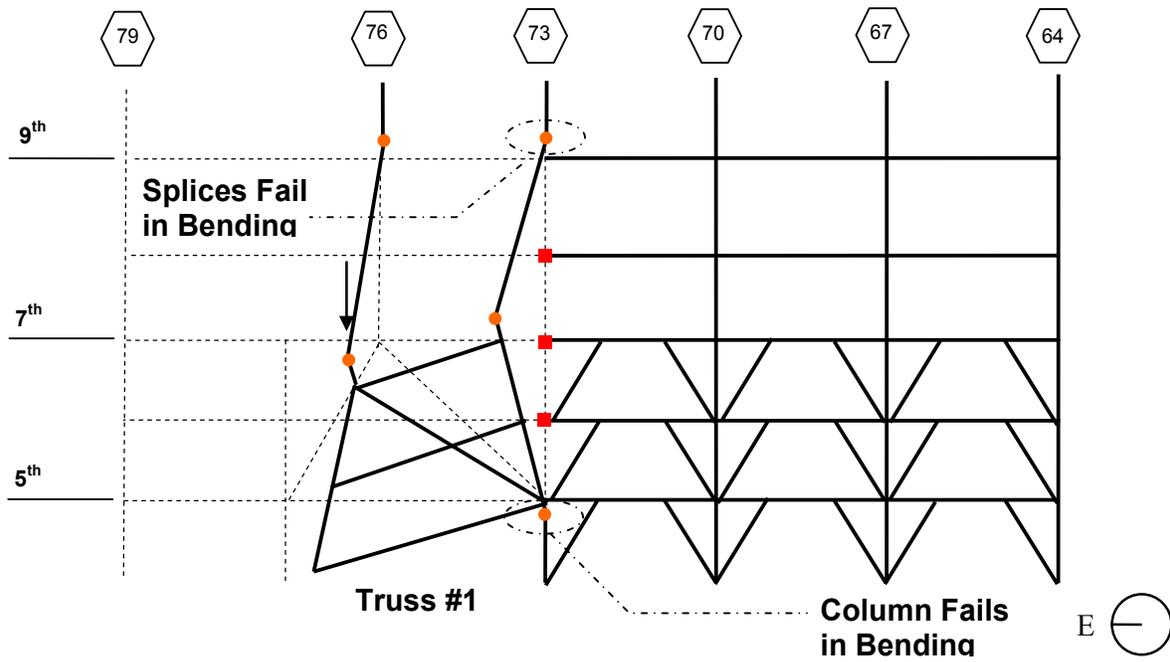
Figure L-48. Horizontal progression mechanism for truss #1 failure.

- **H2.4 Collapse Does Not Progress:** The horizontal tensile force would tend to pull the line of columns 73, 70, 67, 64, and 61 towards the east. The continuity of the Floor 7 slab and the presence of braced frames around the north core column line makes the simultaneous lateral displacement of the core columns less likely, as such displacements within a rigid slab may similarly displace other columns, including perimeter columns.
- **H2.5 Collapse Progresses:** The failure of column 76 may create its own vertical collapse, due to the inability of the floor systems above to redistribute the loads and fail at the column splices near Floors 5 and 7 as shown in Fig. L-48. If column 76 cannot be restrained and there is a vertical collapse of the surrounding bay, it would cause a debris pile at the lower floors which may then destabilize adjacent columns.
